Appendix 1.

Images of the San Francisco stream

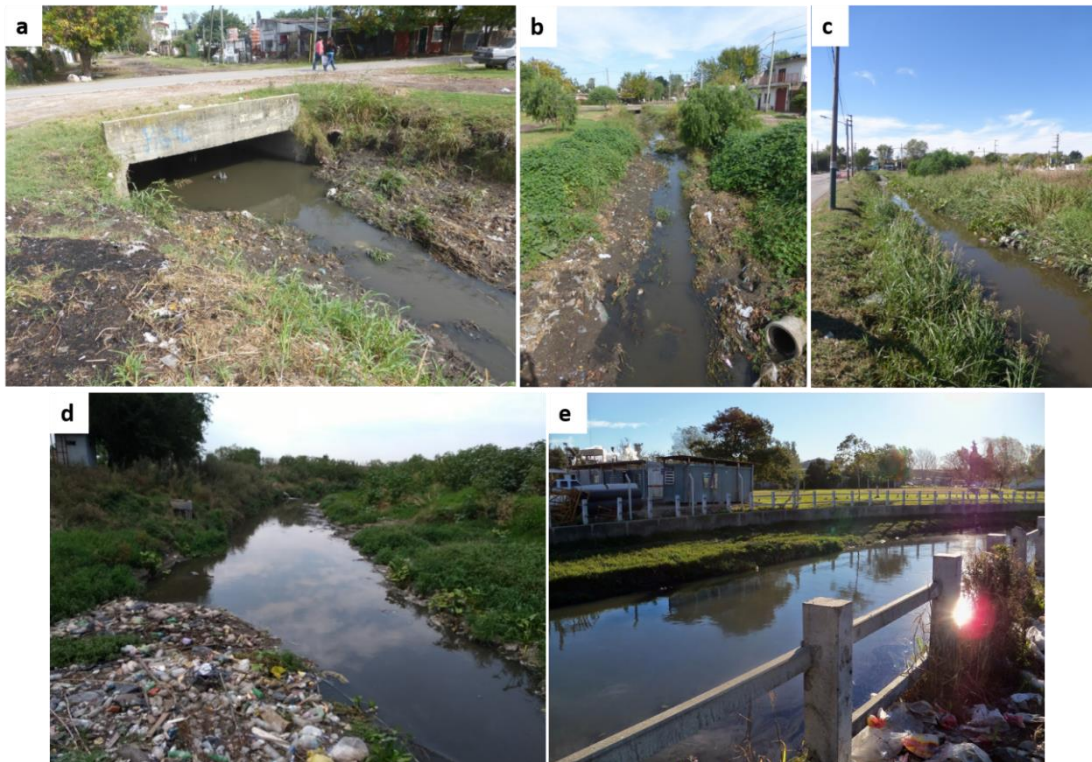
Figure A1.1 Images of the San Francisco stream along its entire course. In A) and B) are depicted images of the headwaters and the emergence to surface at the locality of Claypole (Buenos Aires). Image C) shows part of the stream reach intervened in the work, and D) and E) shows the San Francisco stream near the confluence with Las Piedras stream (Quilmes District), where it can be seen a broader and more degraded stream, with garbage clusters and the presence of concrete structures.

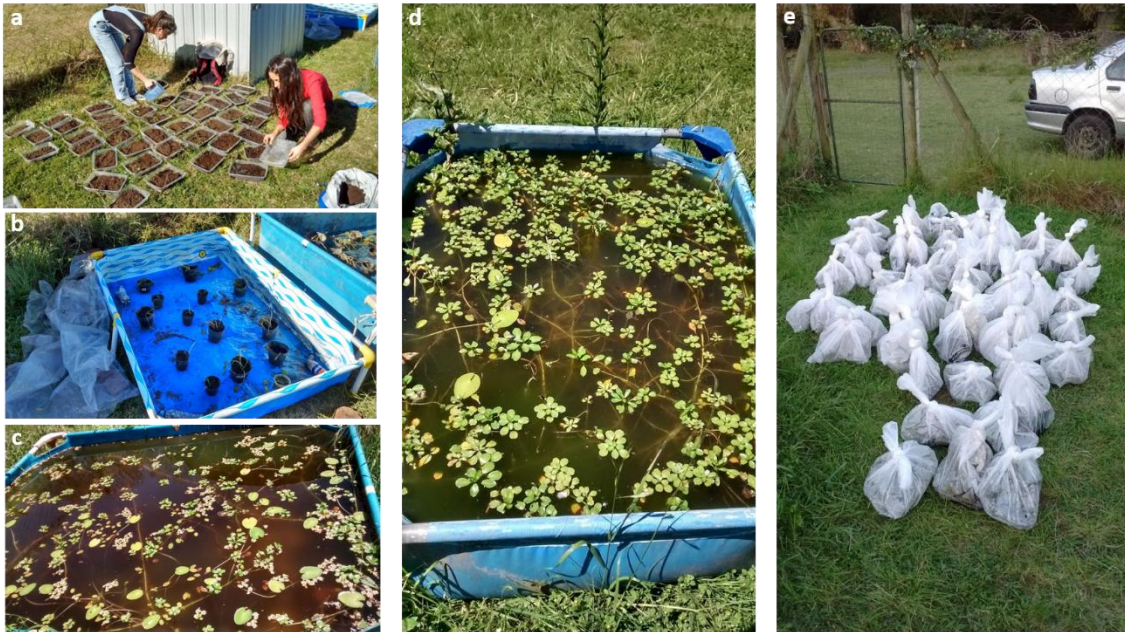
Figure A1.3 Images of the macrophytes cultivation process. In A) and B) are depicted the plastics trays and pots used to delimit experimental units of cultivated macrophytes. Each plastic tray or pot was considered a unique experimental unit. C) and D) shows the growth of experimental units in pools filled with water from the drinking network. E) shows the packaging of each experimental unit for deliver to the working area at the San Francisco stream.
